EXPERT REPORT IN SUPPORT  
OF HONEYWELL DEFENSE  
REGARDING THE TPE331-10R-511C  
TURBOPROP ENGINE, SERIAL NUMBER P42145C,  
INSTALLED ON DE HAVILLAND  
DHC-3 OTTER  
REGISTRATION N93PC  
INVOLVED IN CRASH  
NEAR SOLDOTNA, AK ON JULY 7, 2013

HONEYWELL AEROSPACE  
PHOENIX, ARIZONA  
SEPTEMBER 29, 2017

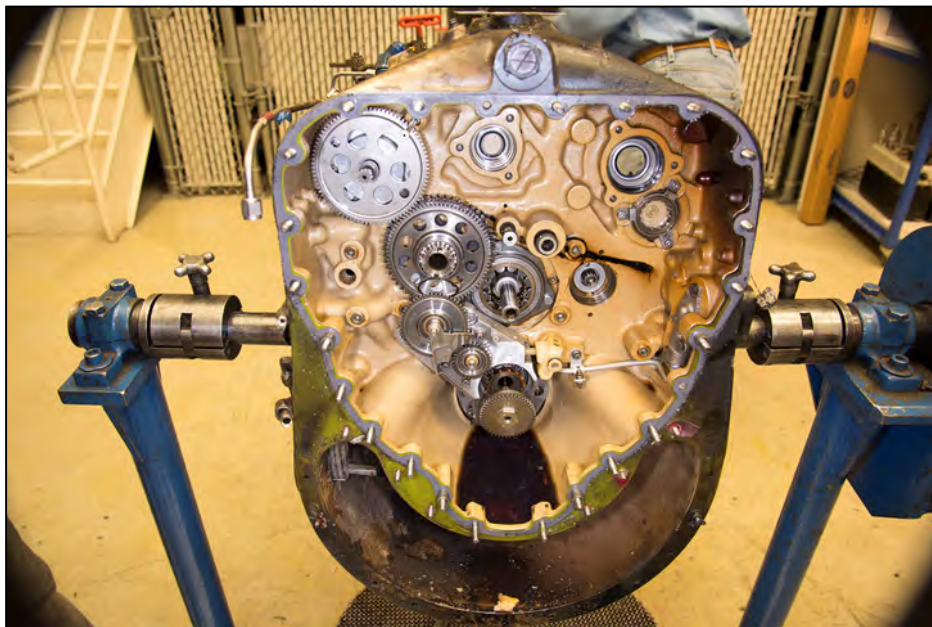
**Figure 4. DDFC Gear Train**

During disassembly, it was noted that rotation of the power section produced a corresponding rotation of the fuel pump/oil pump drive gear through the direct drive fuel control gear train (DDFC), [Figure 4](#). This showed that the gear train from the main shaft spur gear to the fuel pump drive gear was intact. The importance of this finding will be discussed in greater detail in a subsequent section of this report.

The purpose and functionality of the DDFC configuration is not intended to shut the engine down as opined by plaintiff's experts Mr. Sommer and Mr. Coffman. Its purpose is to prevent the overspeed and uncontained separation of the power section components following the uncoupling of the propeller from the power section. There is no mechanism in the DDFC gear train drive that would interrupt the drive to the fuel pump/FCU and interrupt fuel flow to shut the engine down. As noted previously, post-accident examination of the DDFC gear train showed that it was intact.

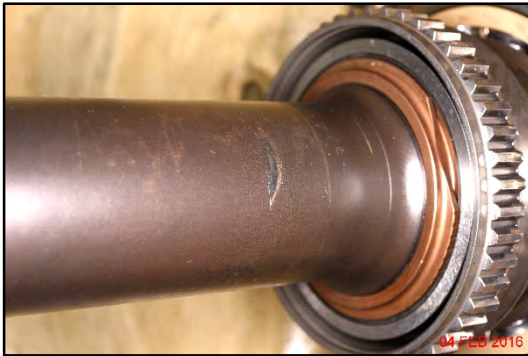
**Figure 5. Propeller Shaft**

- Rotational scoring to the propeller shaft (Figure 5 & Figure 6) with corresponding rotational scoring to the inner bore of the sun gear (Figure 7 & Figure 8).

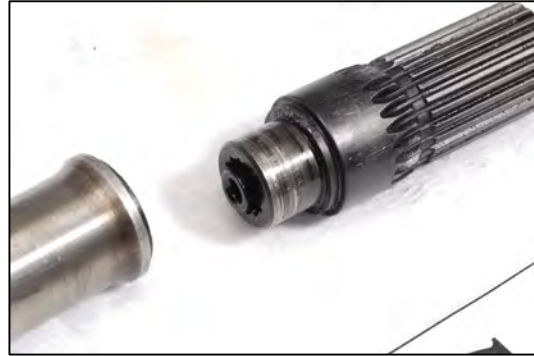
**Figure 10. Torsion Shaft**

- The torsional overload separation of the torsion shaft (Figure 10), which is consistent with the sudden stoppage of the propeller.

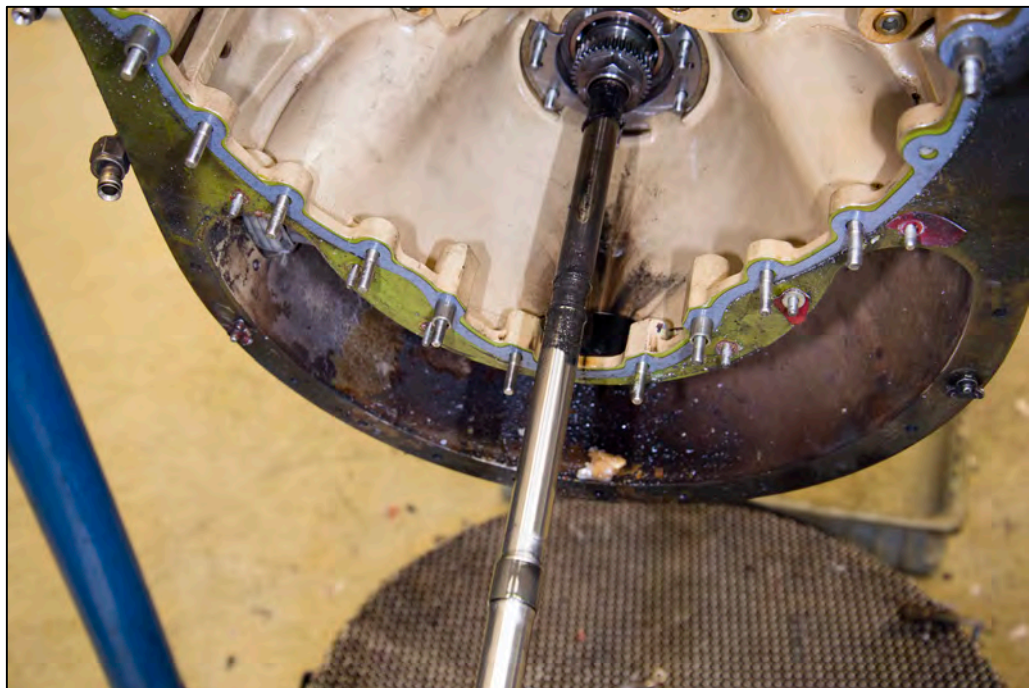
**Figure 11. Torsion Shaft**

- During removal of the torsion shaft from the engine (Figure 11), it was noted that the aft bushing was not intact on the torsion shaft and appeared to have disintegrated. No fragments of the bushing were specifically identified or collected. Any and all debris from the accident engine was returned with the engine upon the NTSB's release with the exception of any waste oil/fuel collected in the drip tray beneath the teardown stand. This was disposed of in accordance with Honeywell's HAZMAT disposal plan with the NTSB's approval.

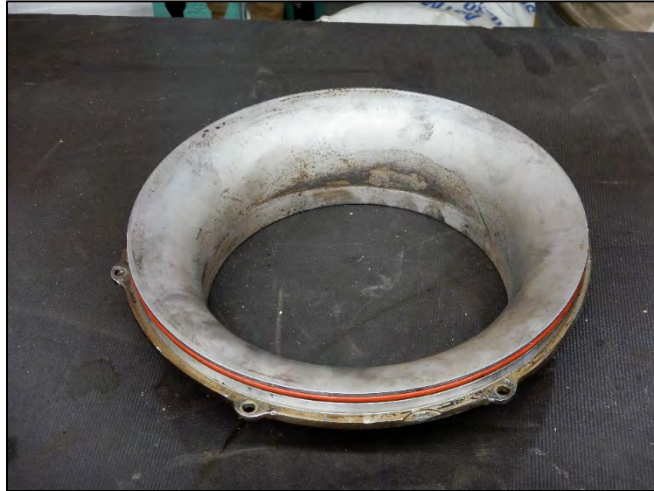
**Figure 12. First Stage Compressor Shroud**

- Rotational scoring damage (rub) was noted to the first stage compressor impeller shroud inducer and exducer areas (Figure 12) with corresponding scoring to the first stage compressor impeller (Figure 13 & Figure 14).

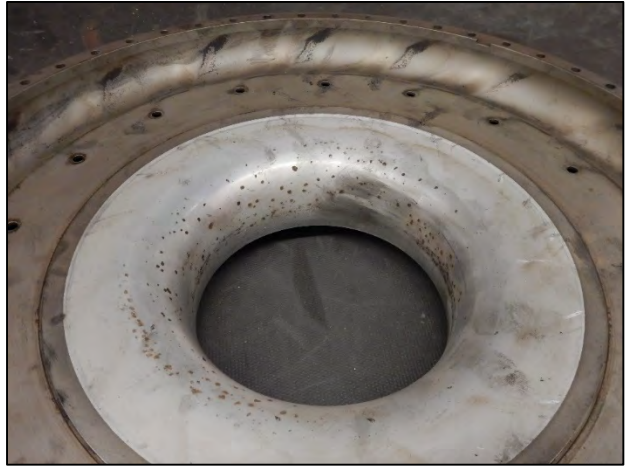
**Figure 15. Second Stage Compressor Shroud**

- Rotational scoring damage (rub) was noted to the second stage compressor impeller shroud at the inducer and exducer areas (Figure 15 & Figure 16) with corresponding scoring to the second stage compressor impeller (Figure 17).
  - Light static contact marks were noted on the second stage compressor impeller shroud. The static marks were on top of the rub indications which evidences that they occurred after impact and the engine had spooled down.

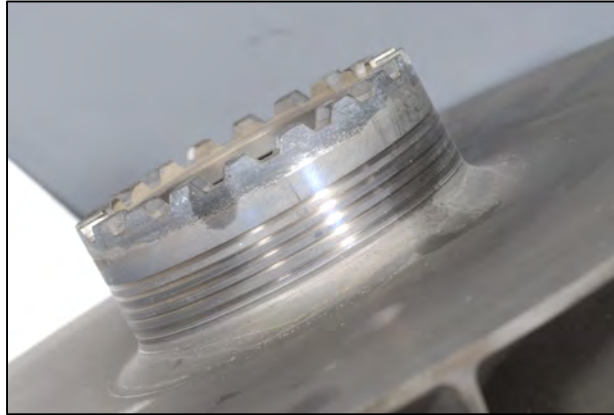
**Figure 18. Aft Hub of First Stage Compressor**

- Rotational scoring damage to the first stage compressor impeller aft hub (Figure 18) with corresponding rotational scoring damage to the crossover duct seal area (Figure 19).

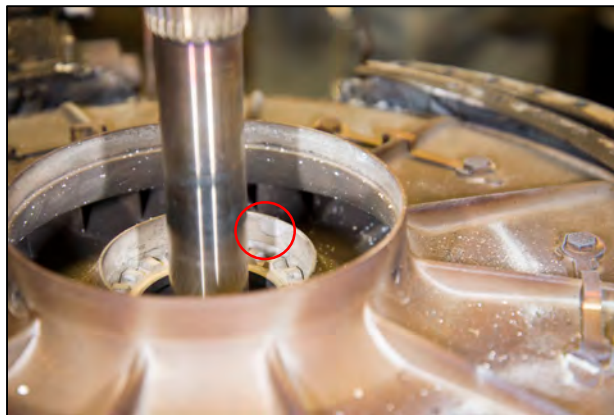
**Figure 19. Crossover Duct Seal Area**

- Rotational scoring damage to the second stage compressor impeller forward hub (Figure 20) with corresponding rotational scoring damage to the crossover duct seal area (Figure 19).

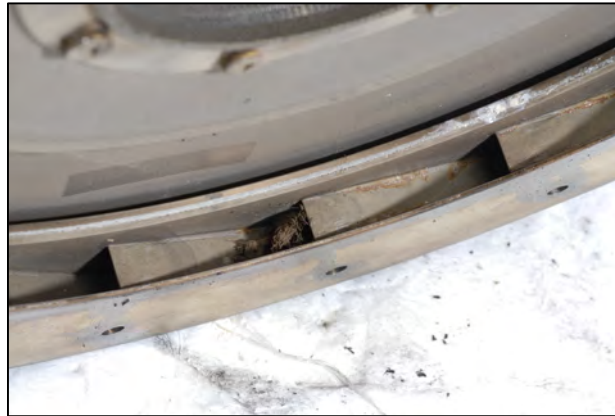
**Figure 21. Second Stage Compressor Diffuser**

- Ingested debris was noted within the second stage compressor diffuser (Figure 21), de-swirl vane assembly (Figure 22) and combustor liner (Figure 23).

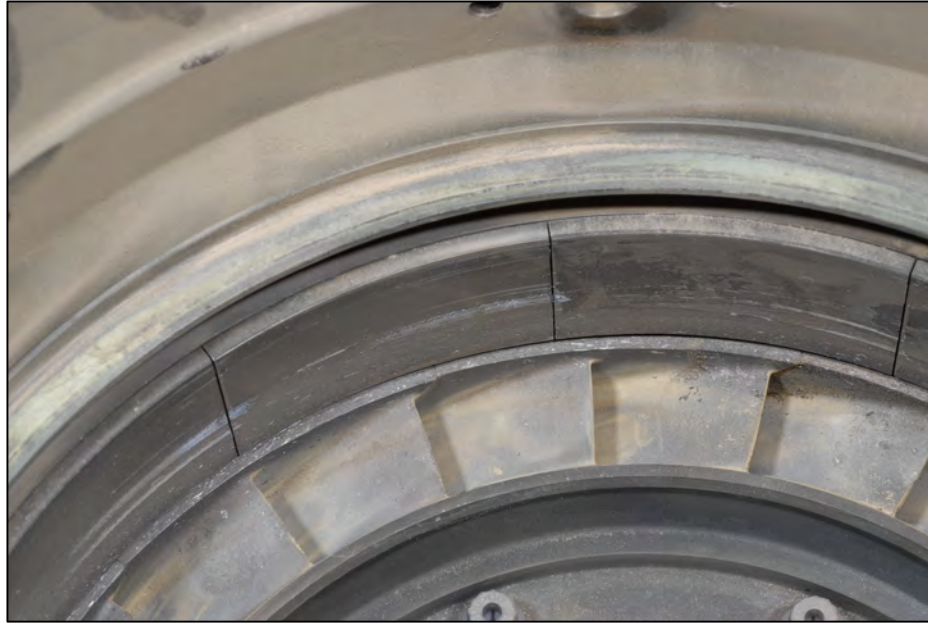
**Figure 24. First Stage Turbine Blade Tip Shroud Segments**

- Rotational scoring to the first stage turbine rotor blade tip shroud segments (Figure 24) with corresponding rotational scoring damage to the first stage turbine rotor blades (Figure 25).

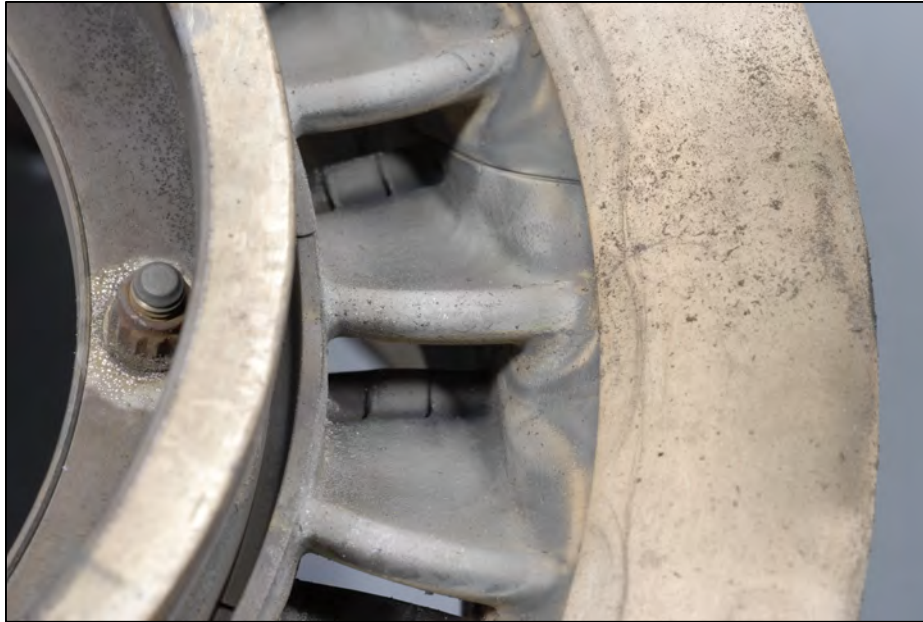
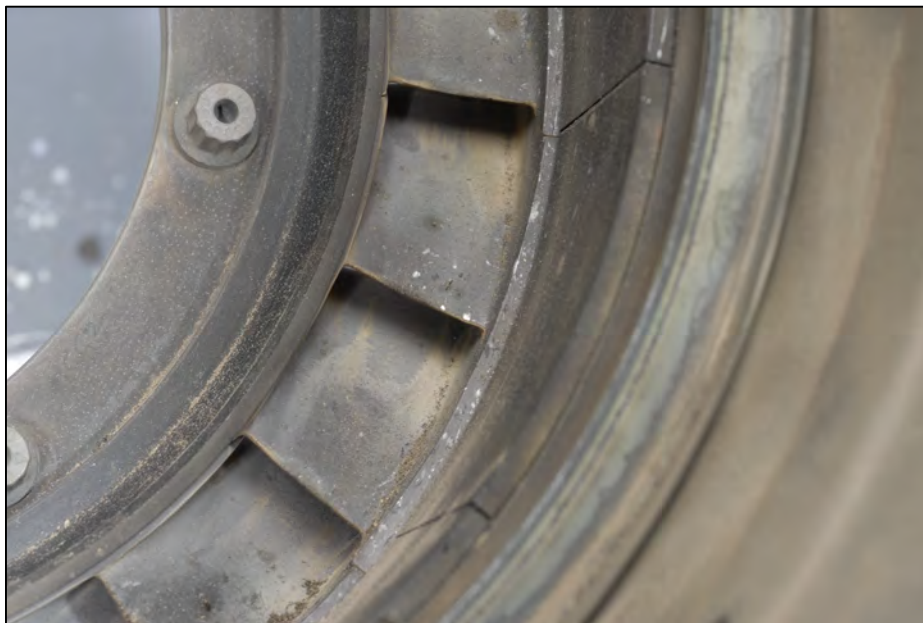
- Metal spray on the leading edge (Figure 26) and suction side (Figure 27) of the first stage turbine nozzle stator vanes.

Metal spray is created during the impact sequence when the rotating impeller(s) come into contact with their respective aluminum coated shrouds. The impellers shave off (rub) the aluminum coating which introduces small aluminum particles into the gas path of the engine. The aluminum particles then enter the reverse flow annular combustion chamber where, in the presence of a flame (i.e. operating engine), they become molten. The molten aluminum particles then impinge upon the downstream rotating and static turbine components, where they form the observed metal spray patterns.

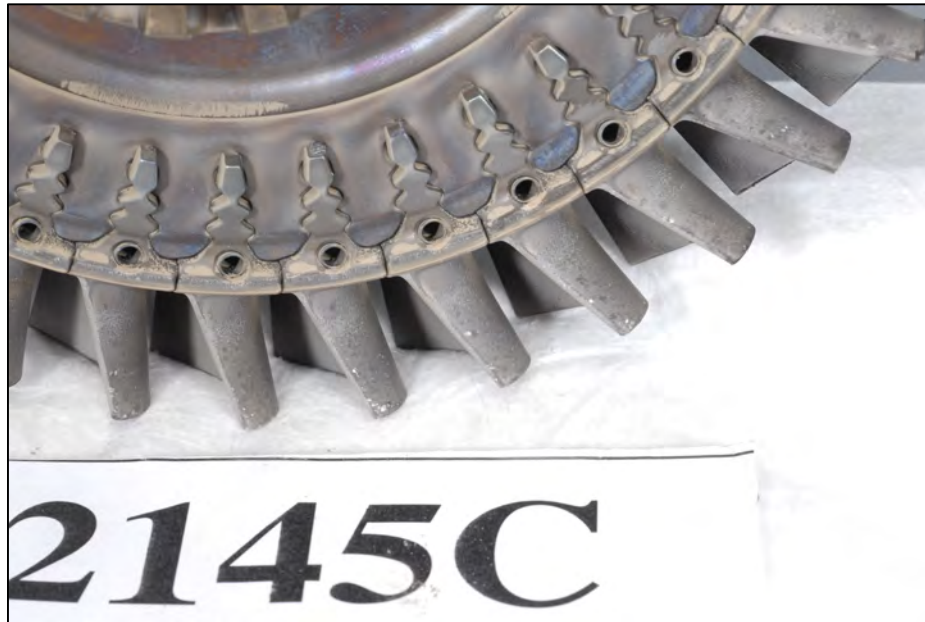
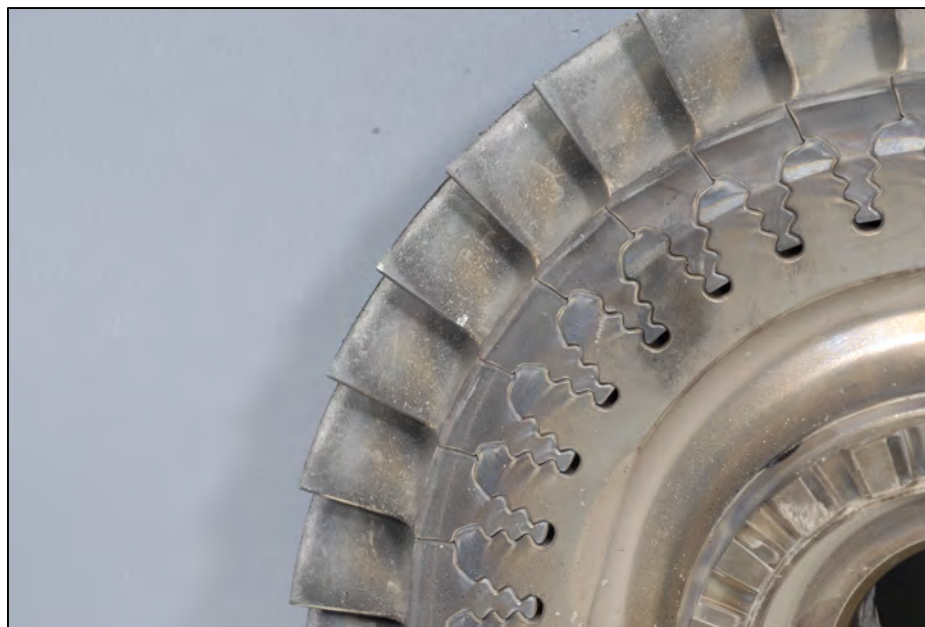
- Metal spray on the leading edge (Figure 28) and suction side (Figure 29) of the first stage turbine blades.

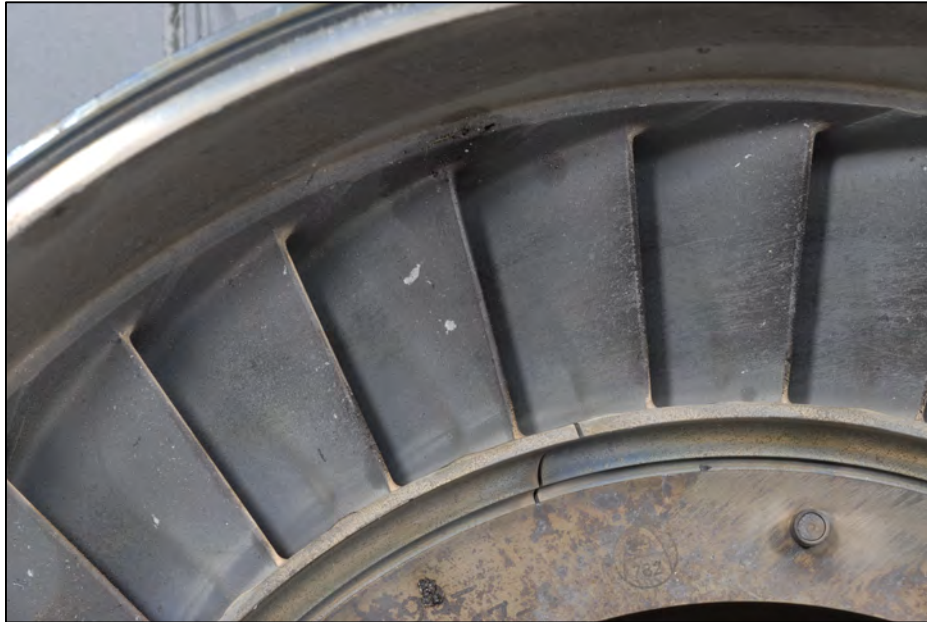
- Metal spray on the suction side (Figure 30) of the second stage turbine nozzle stator vanes.

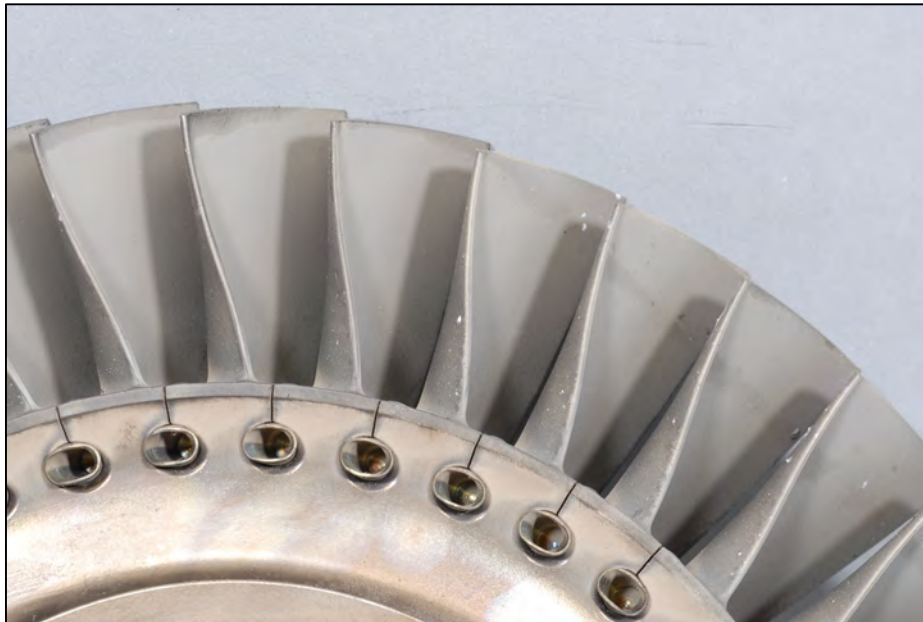
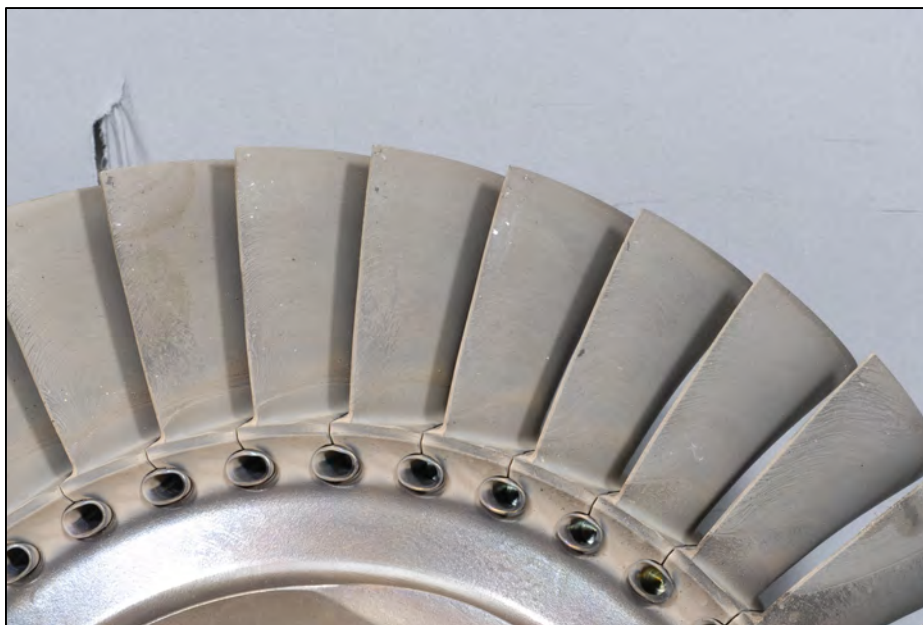
- Metal spray on the pressure (Figure 31) and suction sides (Figure 32) of the second stage turbine blades.

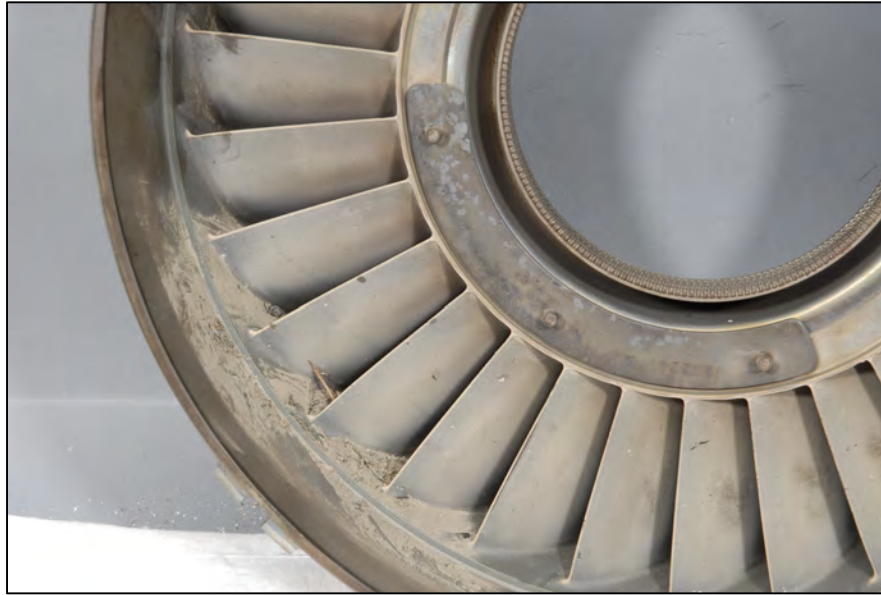
- Metal spray on the suction side of the third stage turbine nozzle stator vanes (Figure 33).

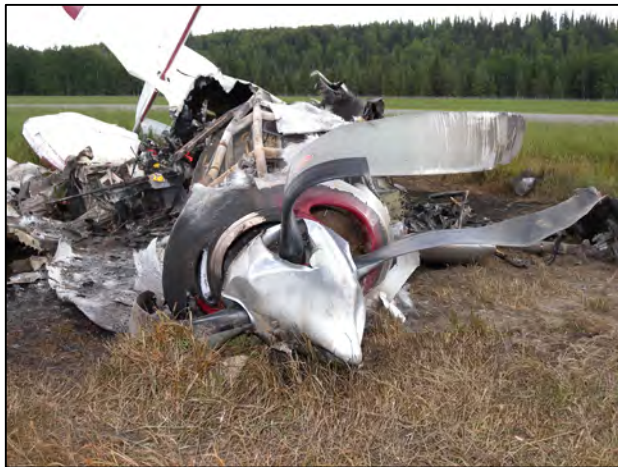
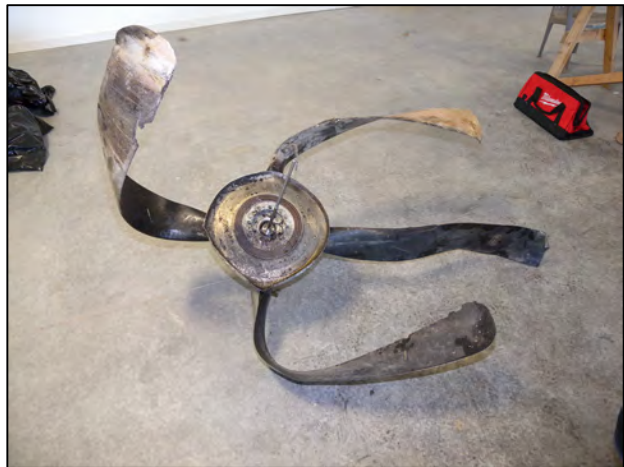
The propeller (Figure 34 and Figure 35) exhibited leading edge tearing and gouging damage to all blades, with 2 blade tips torn and separated. Chordwise scratching was noted to all of the propeller blades. Three of the propeller blades were bent aft and the fourth propeller blade exhibited S-bending. The damage noted is evidence of a powered propeller impacting terrain.

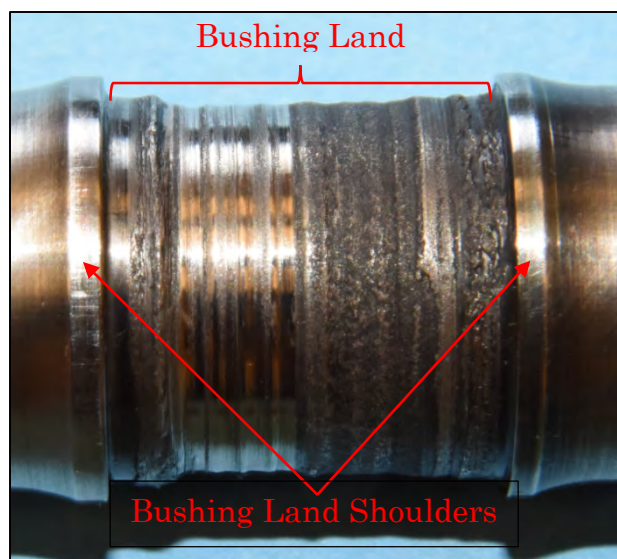
**Figure 41. Torsion Shaft Aft Bushing Land**

No rotational scoring was noted to the shoulders of the torsion shaft aft bushing land. The lack of scoring to the shoulders shows that the torsion shaft did not contact the main shaft after the torsion shaft separated.

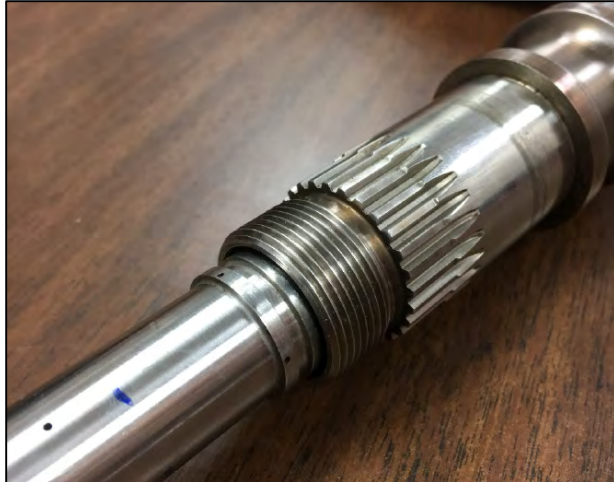
**Figure 45. Partially Installed Deformed Exemplar Torsion Shaft with Aft Bushing Installed, Contact with Main Shaft at O-ring Land**

2. The attempt was made to install the deformed exemplar shaft, with the 2 ea. 866759-1 bushings and the aft 3101703-8 bushing installed, into the main shaft. Light resistance was initially noted. As the torsion shaft was installed to the depth of the torsion shaft O-ring land aft shoulder, metal-to-metal contact was noted. The torsion shaft contact with the main shaft prohibited the continued installation of the torsion shaft (Figure 45).

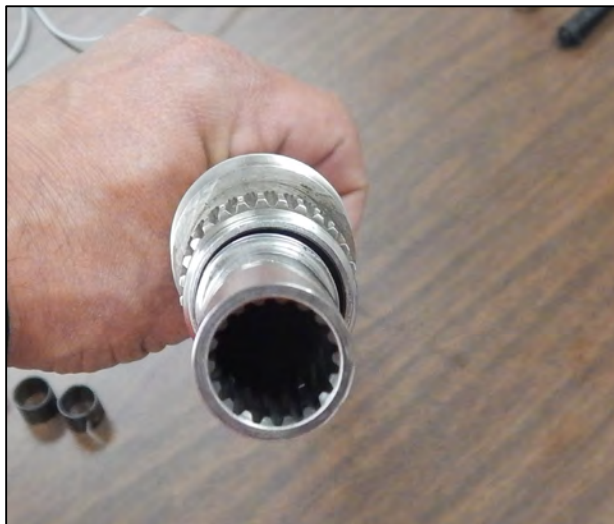
**Figure 46. View of Radial Displacement between Main Shaft and Deformed Exemplar Shaft, Aft Vespel Bushing Installed, Bronze Bushing Not Installed**

Figure 46 illustrates the relative radial mismatch between the deformed exemplar torsion shaft and the main shaft at this point.

normally would not have proceeded with the assembly without investigating the cause of the problem. The torsion shaft was further installed using force until the contact reached the bronze bushing location. At that point, the aft edge of the bronze bushing comes into hard contact with the inner diameter of the main shaft opening and the torsion shaft cannot be inserted further without unseating the bronze bushing.

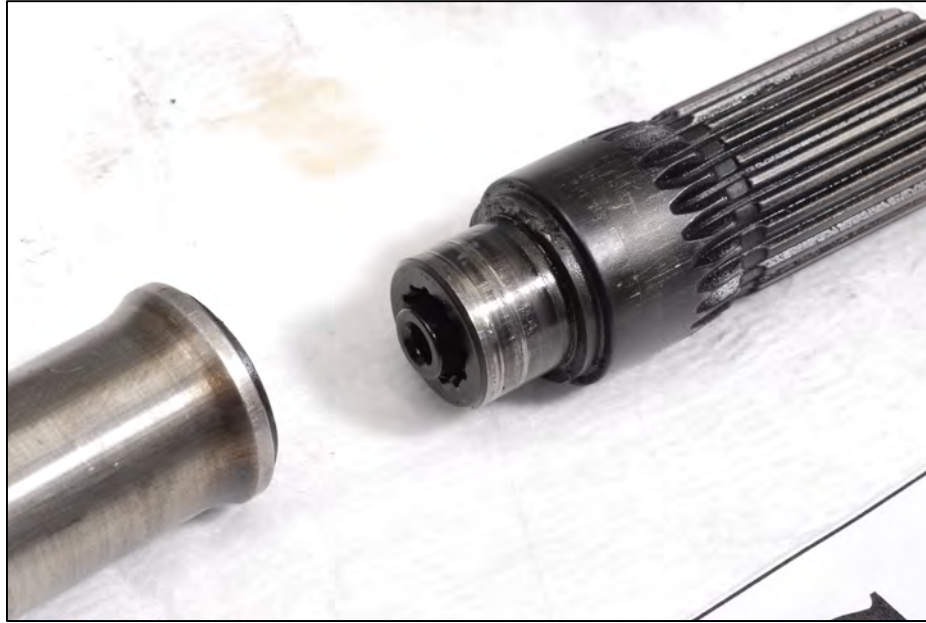
**Figure 47. Separated Torsion Shaft**

1. After the torsion shaft fractured at impact, the power section of the engine continued to operate for a period of time, which caused the main shaft to rotate around the now stationary portion of the torsion shaft (forward of the separation) at approximately 43,400 RPM (104%). The aft bushing remained affixed to the inner diameter (ID) of the main shaft and in essence became a journal bearing at the aft bushing ID and torsion shaft outer diameter (OD) interface, which resulted in significant relative rotation. The friction associated with the relative rotation between the two surfaces caused the noted aft bushing land distress. This is evidenced by the localized discolored (heat affected) area at the aft bushing land, the uniformly removed and redeposited shaft material around the circumference of the land, and the total destruction of the aft bushing. The ESI laser scan of the torsion shaft showed an approximate 43% decrease in the nominal wall thickness at the aft bushing land. The localized heating due to friction and the shaft wear are partially responsible for the deformation noted to the post-accident torsion shaft.

The bend could not predate the torsion shaft separation. Plaintiff expert Mr. Sommer opined that the torsion shaft was installed in the engine in its bent condition. This is not consistent with the findings. A bent torsion shaft, i.e. biased to one side of the main shaft ID, would produce locally heavy wear to the area of the torsion shaft bushing land that is opposite the biased direction. The wear to the torsion shaft bushing land is uniform around the circumference. The uniform circumferential wear to the torsion shaft bushing land is conclusive evidence that the torsion shaft was not installed in the engine in a bent condition.

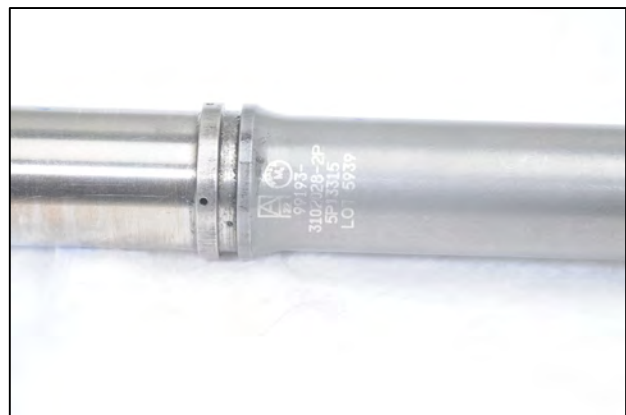
**Figure 49. Salvage Torsion Shaft**

The 3102028 torsion shaft (Figure 49) is a different part number than the accident torsion shaft in question but its function is identical. The shaft was separated forward of the aft splines (Figure 50), consistent with torsional overload. The forward bushing land of the salvage torsion shaft exhibited wear indications (Figure 51).

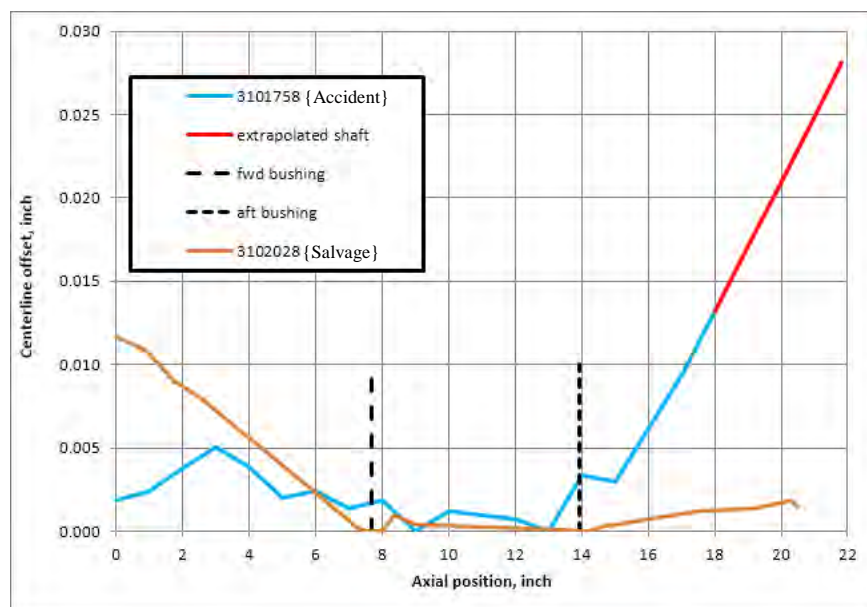
**Figure 52. Graphical Comparison of the Torsion Shafts' Deformation**

Inspection of the runouts identified that the shaft was bent and the bend originated at the forward bushing land. This further evidences that the deformation is due to the wear at the land and localized heating. Figure 52 provides a graphical comparison of the bends relative to the locations of the bushing lands for both the salvage and accident torsion shafts.

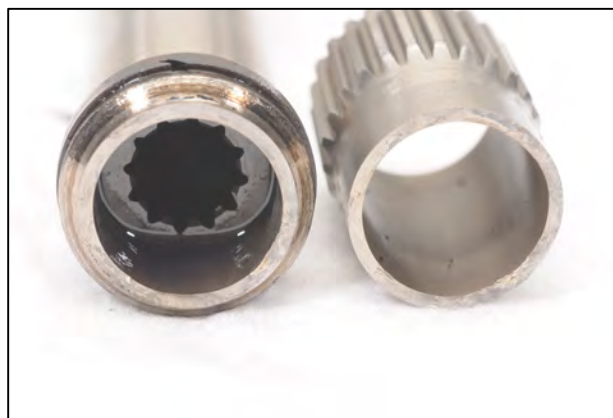
**Figure 53. Salvage Torsion Shaft**

The salvage torsion shaft separated aft of the oil scavenge pump drive spline insert (Figure 53). Thus, the scavenge pump would not be driven by the operating power section after the propeller strike and uncoupling of the propeller. However, as discussed in the previous section, the DDFC is still driving the fuel pump, FCU and oil supply and scavenge pumps within the gearbox. Thus, the turbine bearing cavity continues to receive supply oil while the engine is rotating. The turbine bearing cavity will fill with oil since the scavenge pump is no longer functioning. Once the oil level in the cavity reaches the height of the gearbox return through the hollow scavenge pump drive shaft, oil will flow through the stationary portion of the torsion shaft. The wear and localized heating at the bushing land coupled with the

differential thermal expansion discussed above, caused the shaft to bend. The condition of the torsion shaft from the De Smet accident engine demonstrates that a torsion shaft in an engine operating at impact can develop a post-impact bend.

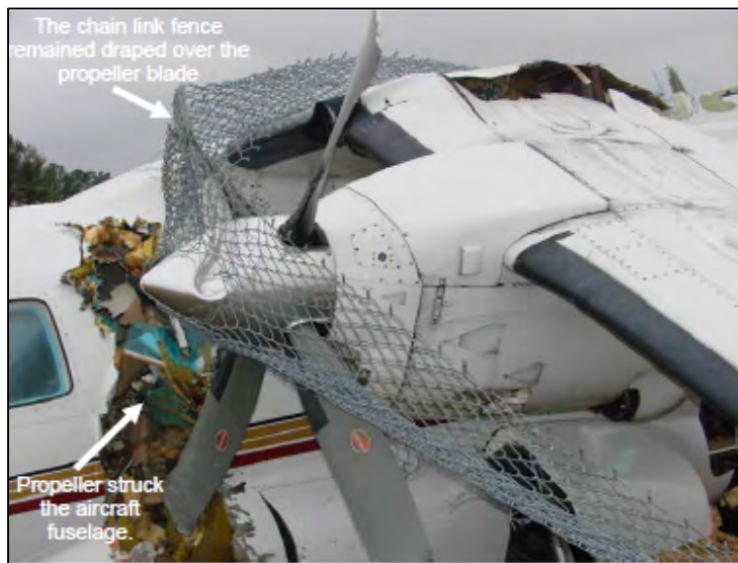
**Figure 54. Millington, TN - ERA09FA083<sup>12</sup>**

Figure 54 shows the damage caused by left engine propeller strike when the aircraft hit the fence. It also shows the uncoupled propeller draped with the chain link fence. However, as reported by the fire fighters, the power section continued to run.

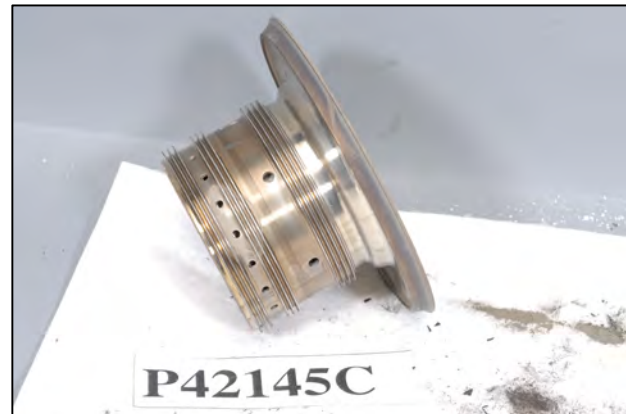
**Figure 58. Center Curvic Coupling**

No evidence was noted on the center curvic coupling (Figure 58) or the seal area (Figure 59) to indicate that the engine experienced shaft bow operation in the past. Operating the engine in a shaft bow condition will result in a radially offset load and would be evidenced by localized damage to an arc

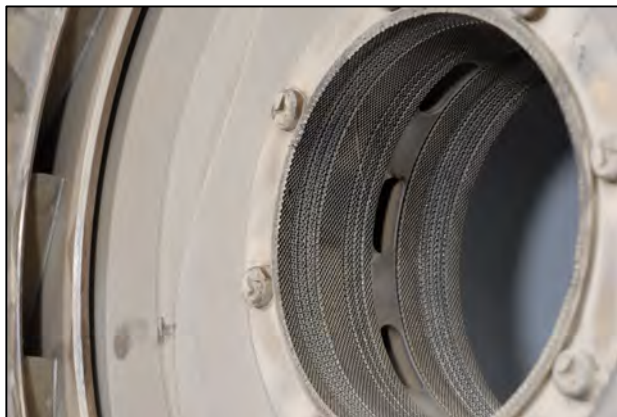
**Figure 59. Abradable Seal**

of the coupler knife seals and circumferentially uniform damage to the stationary abradable seal. Because of the radial displacement of the shaft, all damage to the static structures within the engine (compressor shrouds, abradable seals, turbine blade tip shrouds, etc.) will be uniform thru 360

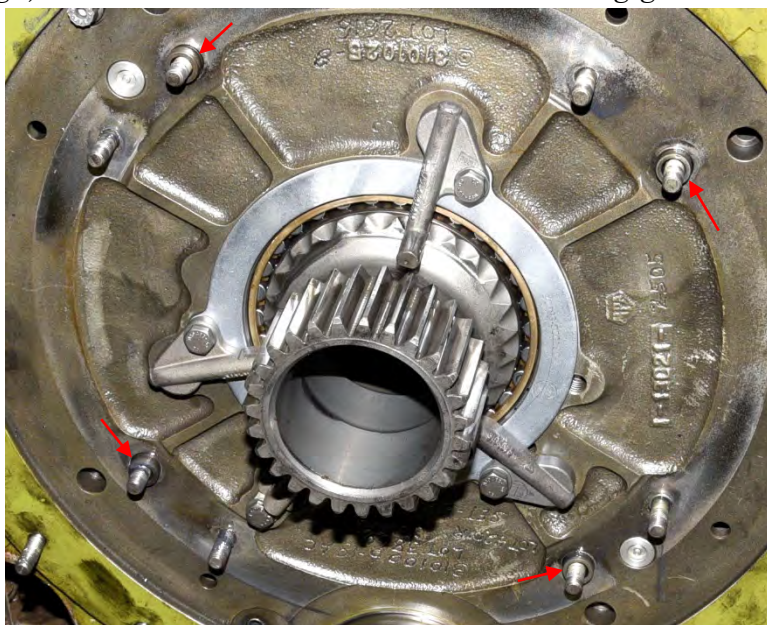
**Figure 60. Ring Gear Support Mount Dowels**

Photographs taken by plaintiff expert Mark Hood during the February 4, 2016 engine examination in Anchorage, Alaska showed the condition of the ring gear support mount dowels (Figure 60). All 4 of the dowels are displaced in the counter-clockwise direction, forward looking aft. Only a coupled engine at impact will produce this damage signature. As the propeller impacts terrain (sudden stoppage), the engine power section is no longer able to transmit all of its energy to the propeller. The excess energy and inertia of the rotating power section caused the planetary gears to
